## **SUMMARY REPORT**

Environmental Site Assessment and  
Preliminary Risk Assessment for  
Mercury

Kodaikanal Thermometer Factory,  
Tamil Nadu

24 May 2001

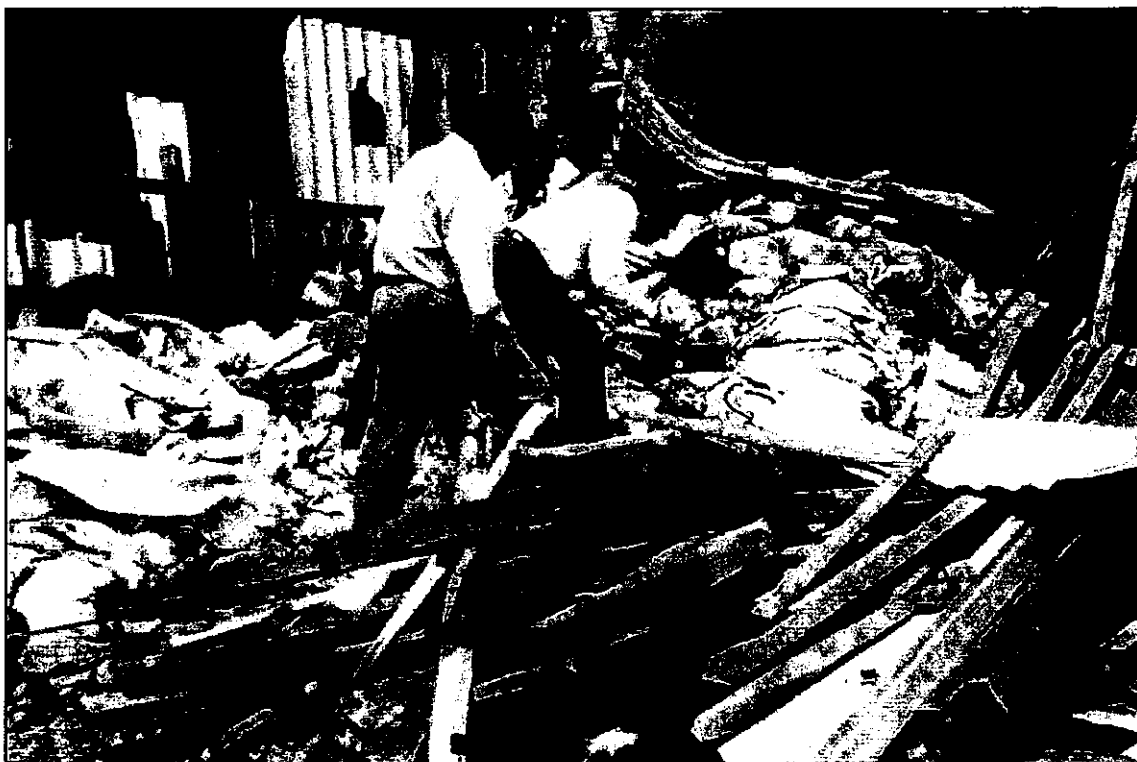
Approximately 5.3 tonnes of glass cullets, as 3 and 4 glass scrap, are stored in a scrapyard in Kodaikanal. This was sold to the scrapyard in November 1999 and is currently located in two small stockpiles amongst other scrap waste. The glass scrap was treated for mercury recovery before disposal from the factory and contains between 0.15% and 1.0% metallic mercury. On this basis the material contains slightly more than 50 mg/kg of mercury and is classified as a Hazardous Waste.

Plate 1: Kodaikanal Scrapyard : Measuring mercury concentrations in air at stockpile of 3 & 4 glass scrap. Note granite bedrock near rear

It should be recognised that retrieval, drumming, transport and storage of the waste will occupy an elapsed time of no more than two days and will involve no more than 20x 200 litre drums of waste glass and soil. The potential exposure of workers and nearby residents to mercury vapour and dust during the operation is therefore limited. The proposed protocol involves the following steps:

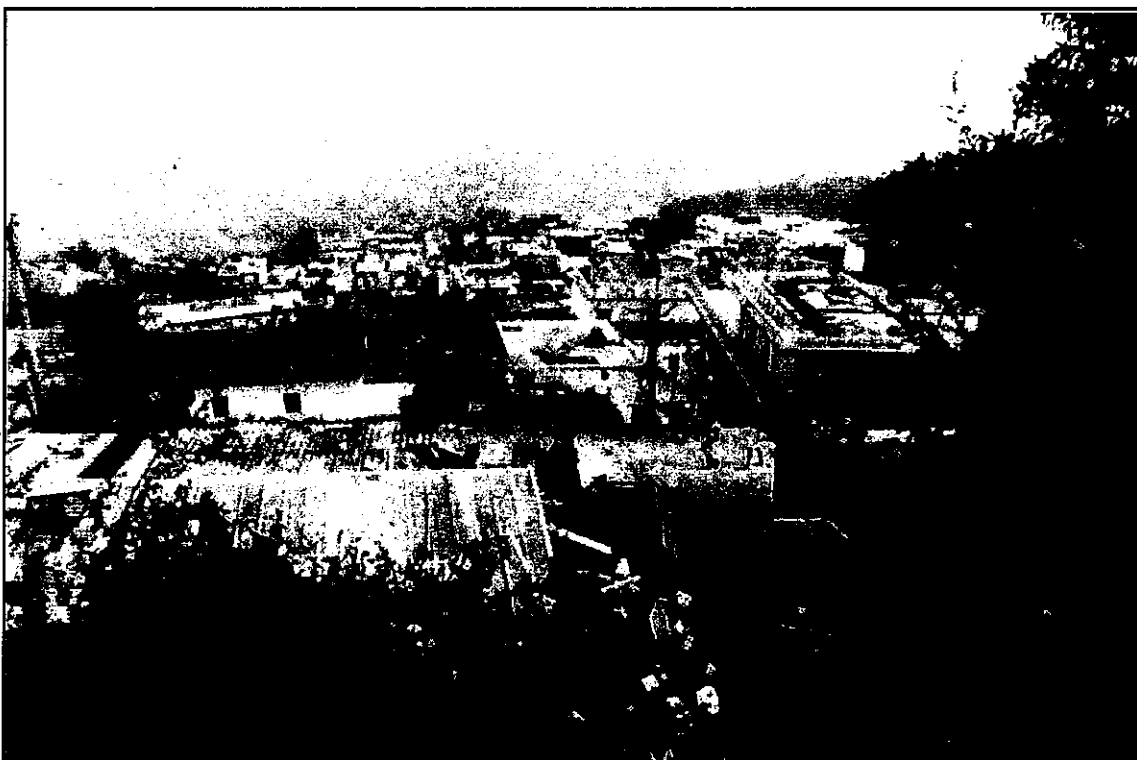
Plate 2: Kodaikanal Scrapyard : View looking down over scrapyard. Truck is parked at second stockpile of 3 & 4 glass scrap
