Study on soil conservation while undertaking soil remediation process in mercury contaminated site of Hindustan Unilever Ltd., Kodaikanal

Prepared for
Hindustan Unilever Limited
Kodaikanal

**Central Soil & Water Conservation Research &
Training Institute: Research Centre**
Udhagamandalam - 643 004

October 2010

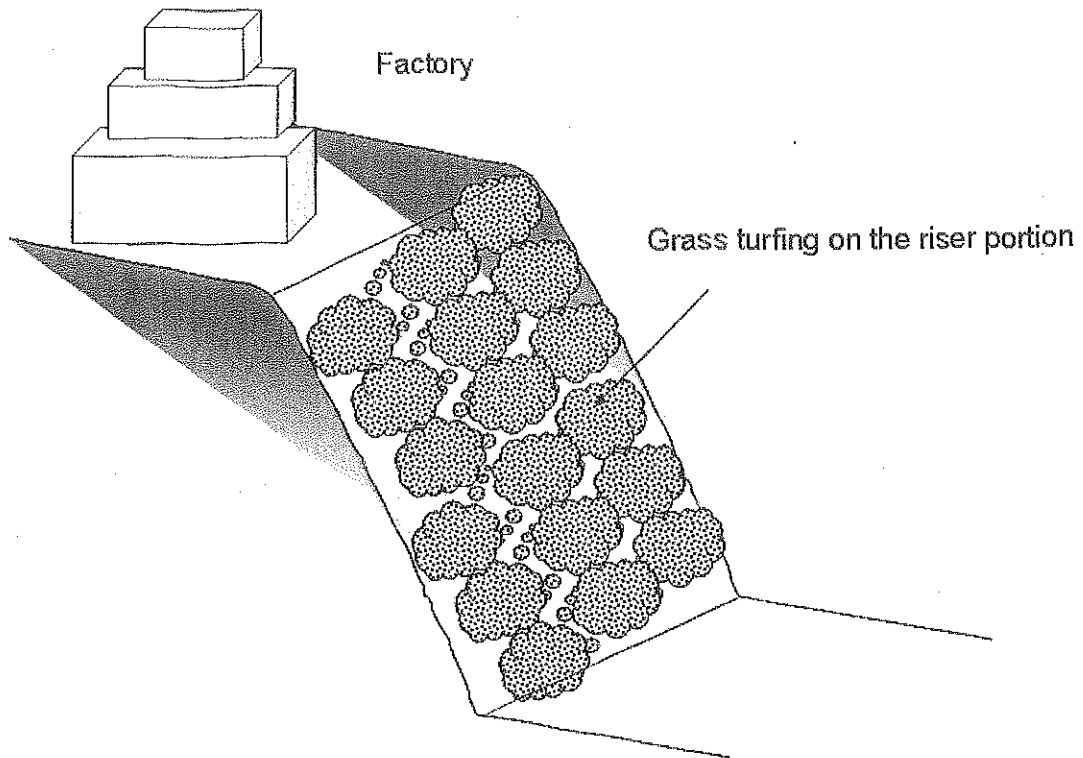
The critical slope on the riser is $\leq 35^\circ$ behind the factory building, hence there is possible of severe erosion during rainy season due to insufficient compactness of the soil. Therefore, riser part behind the factory building has to be protected by spreading a thick layer/ bunch of locally available grasses. In general while removing soil on the riser portion nearby building side should be maintained with 1:1 or 1½: 1 slope. Some of the grasses may include *Chrysopogon fulvus*, *Cymbopogon spp.*, *Eragrostis curvula* (weeping love), *Pennisetum clandestinum*, *Cynodon dactylon*, *Saccharum spp.* etc.

Fig. 2 Grass Turfing on riser portions behind factory building of HUL

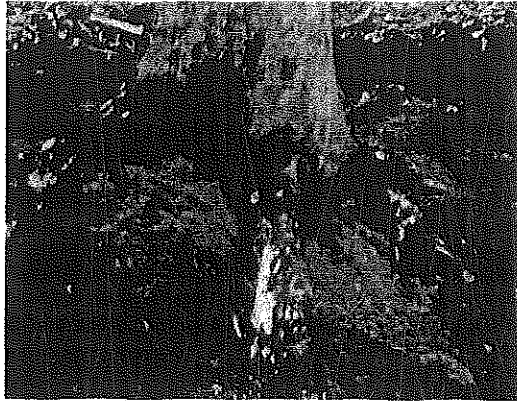
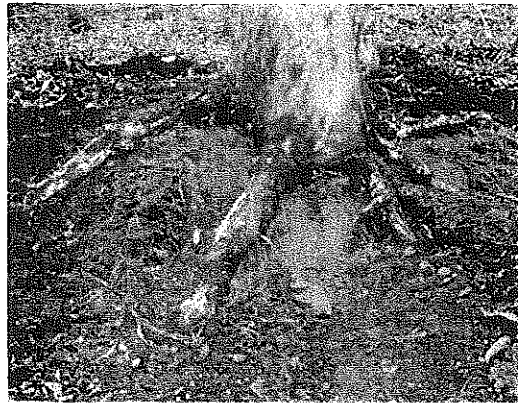
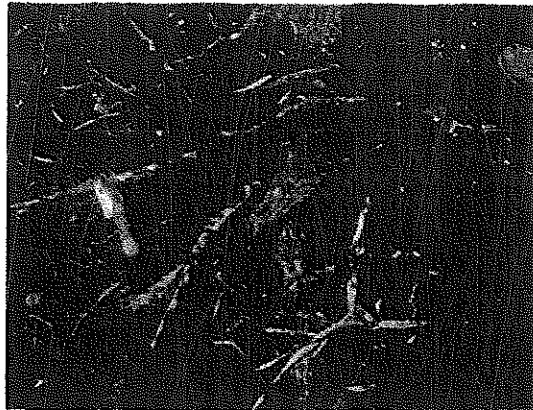
Plate 1: Shallow root distribution systems existing in study area

- In general where the trees are located in dense or close spacing, excavation of soil should be completely avoided. At other places, for specified distances as given in Table 4, the soil should not be disturbed.

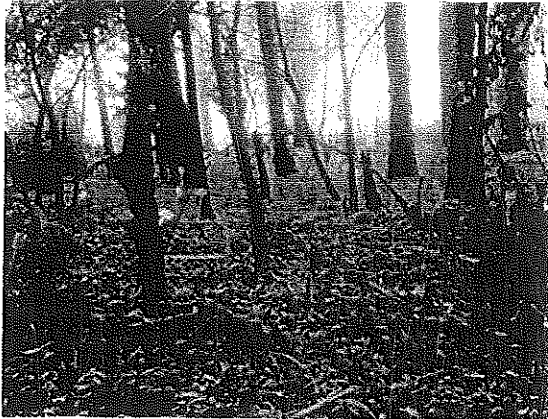
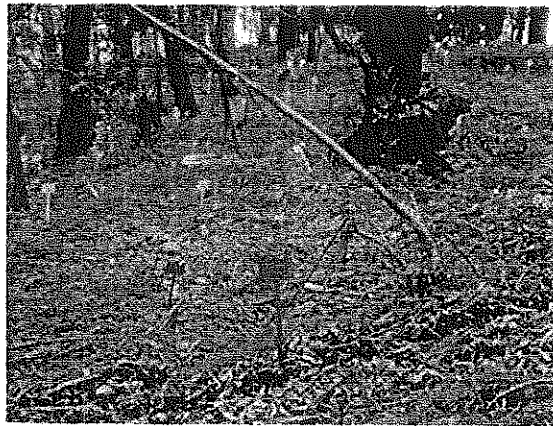
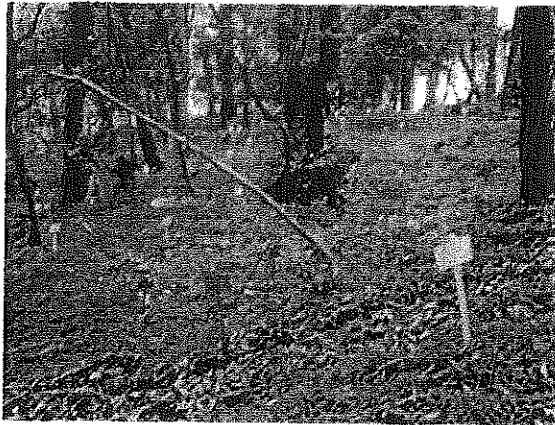
**Plate 2: Forest area where stone bunds are proposed in
Between trees after back filling**

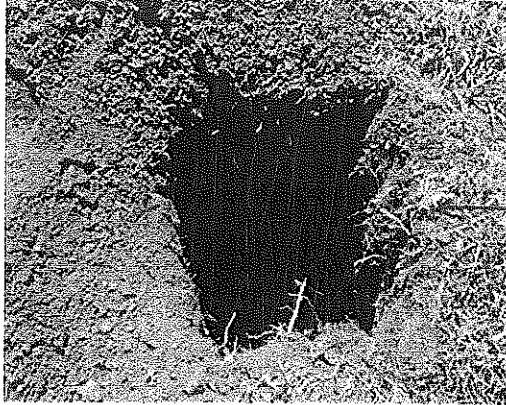
Area C2: The soil depth is > 0.60 m., out of which the top fertile soil along with leaf litter is 0.30 m and the sub-soil depth is > 0.30 m. The parent rock is chornokite. At present some stone terraces are in damaged conditions in few of the areas within Area C2.

Area C - deep soil depth

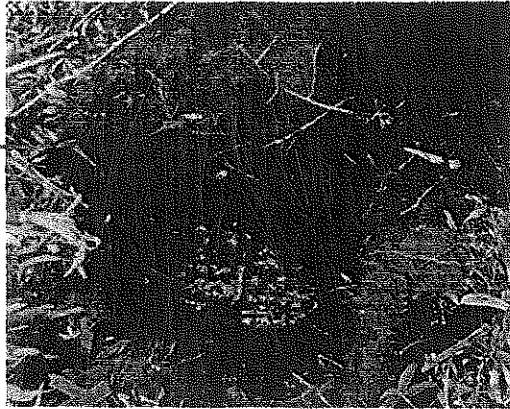
Area B - Moderate soil depth

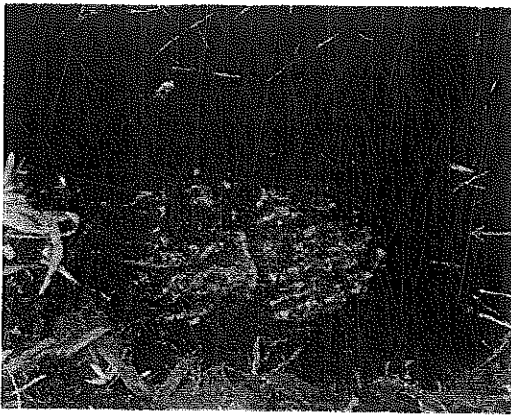
Area A: In most of the places, stones and rubbles are found in the soil surface. The soil depth is shallow i.e soil depth ≤ 0.35 m, out of which the top fertile soil along with leaf litter is 0.20 m deep and the sub-soil depth is only 0.10 to 0.20 m. The parent rock is chornokite.

Area A - shallow soil depth

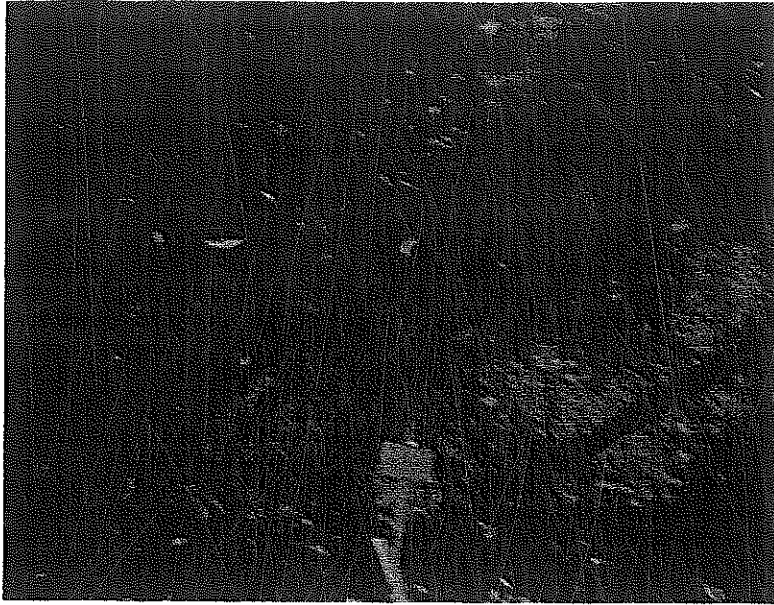
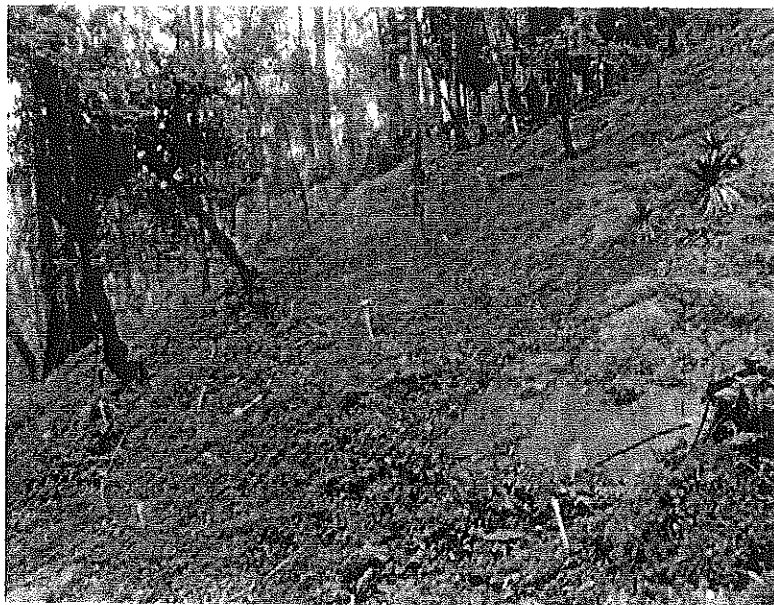
This is a critical zone where depth of soil is very shallow ≤ 0.25 m, slopes are steep (33 to 50 per cent) and some of the patches the parent rocks are exposed. If soil is backfilled in this area, the soil could potentially be washed away in heavy rain events due to its reduced binding capacities and steep slopes. The estimated soil loss would be varies from 45 to 50 tonnes / ha / year. Hence, the following conservation measures are recommended in this area.

Plate 4: Steep slope area with rocky patches where excavation and backfilling is not possible in area A

- It is suggested to not to disturb the soil where the steep slope area of 'A' Zone (as demarked in Map 3) having above 50 % land slope. Instead, in-situ measures should be taken up to avoid the movement of mercury contaminated soil from this area to neighboring areas. Covering with Geo-Jute blankets and planting grass species will be the suitable option to avoid the soil movement.
