Report of Lichen, Moss and Sediment Sampling around the premises of Hindustan Unilever's Mercury Thermometer Factory in Kodaikanal

Community Environmental Monitoring
June 2015

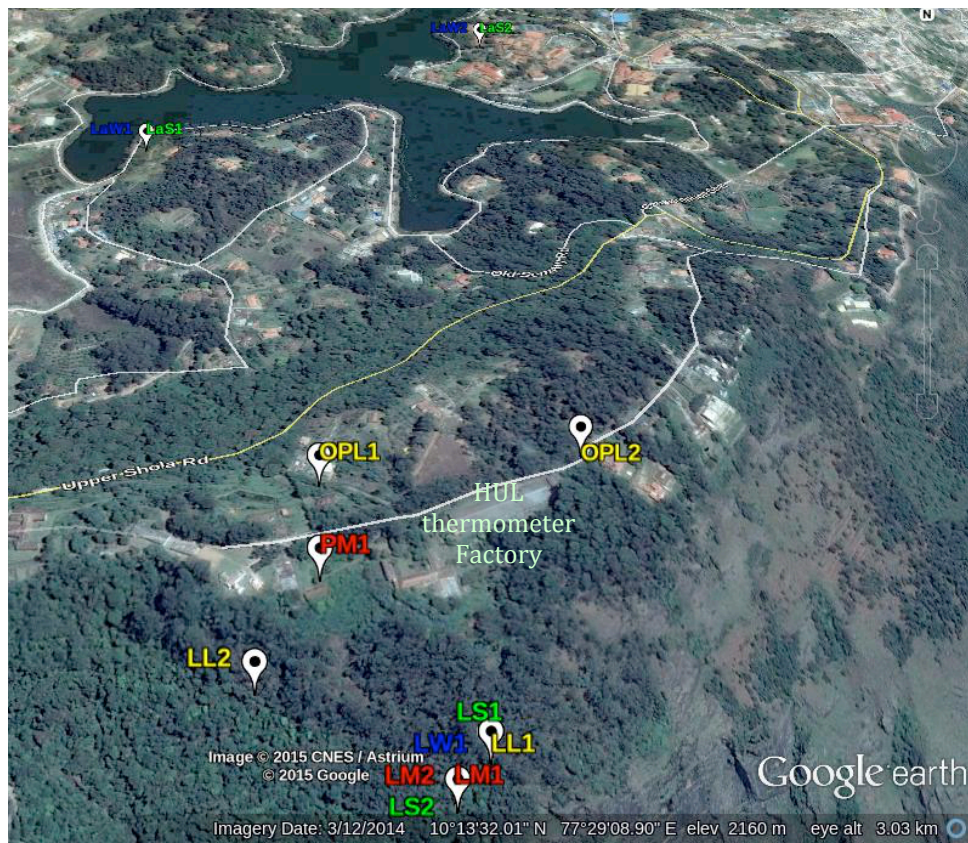
SAMPLING LOCATIONS ON A MAP

The most contaminated samples of lichen and moss were found on the Levange path in Pambar Shola Reserve Forest from around a stream that flows out of the factory into the Shola watershed. The lichen sample contained 53 mg/kg of mercury; moss contained 8.68 mg/kg. One lichen sample collected from around Charlemont – a private property across the street (St. Mary's Road) from the factory – contained 2.96 mg/kg of mercury, indicating higher-than-background mercury levels in the ambient air in this residential area. Other lichen and moss samples contained less than 1 mg/kg mercury.

The sediment samples with the highest levels of mercury were collected from inside the Pambar Shola. One sample (LS1), collected from a stream that flowed out of the factory site, was found to contain 1.52 mg/kg of mercury. Another (LS2) collected nearby contained 0.54 mg/kg.
